**Abstract:** To this day we have seen many cases of accidents of breakdown of steel cover frames as a result of depletion of carrying capacity of their compressive frames. It can be said that in higher frames, like covered constructions of contemporary stadiums, the possibility of the compressive bar losing the resistance is bigger than in case of compressive belt. With help of software product the bearing constructions of stadium coverage has been modeled by opening frames, reclined one another. When we start to rise the snow load, which is effecting to the construction by pressure, one of the frames losing its resistance. As a result of this, the all covered constructions had been destroyed. The method has been developed with the hepl of the appearance of local destructions can be avoid and the stability of bearing construction can be enhanced.

**Key words:** big-opened frames, coverage of the stadium, losing resistance, bearing constructions stability enhanced

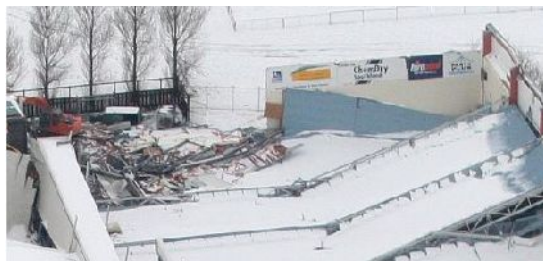
. 5

( . 5) [5],

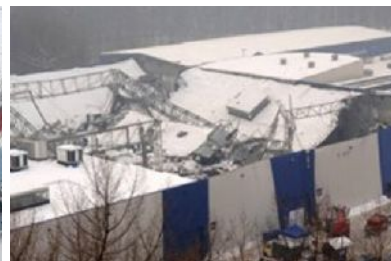
. 6

, ( . 6).

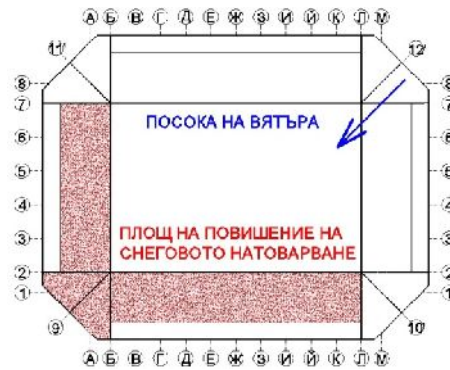
. 9.

( . 9).

45°

1,55 kN/m<sup>2</sup>
